Reflections about the restoration of a rammed earth Islamic tower

C. Mileto & F. Vegas López-Manzanares

Instituto de Restauración del Patrimonio, Universitat Politècnica de València, Valencia, Spain

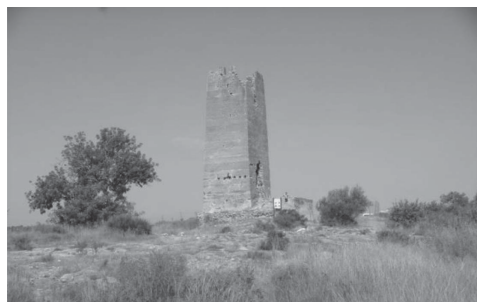
Figure 1. Bofilla Tower in the surrounding landscape before its restoration (Vegas & Mileto).

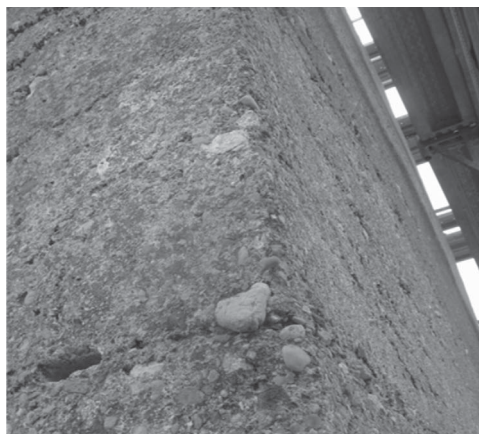
On the other hand, we know its construction was rather hasty because home-made formwork was used to build it—probably the planks used to build the farmstead at the foot of the tower—which were connected by means of nailed posts. The planks available were insufficient to cover the whole perimeter of the tower, so that the tower was built with a U-shaped formwork that was moved after the earth had been compacted to complete the perimeter, thus avoiding any joints at the corners that might weaken them (Fig. 2).

Figure 2. Corner of the tower that shows the continuity of the rammed earth wall (Vegas & Mileto).

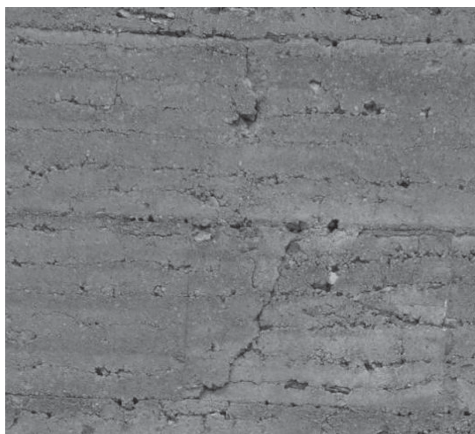
Figure 4. Successive courses showing alternatively inclined joints (Vegas & Mileto).

the successive courses so that the entire ensemble would look well bonded, not only at the corners but all over (Figs. 3 and 4). The horizontal joints in the rammed earth were sealed *al fresco* at the top and bottom of the tower with 15 cm strips of mortar with a large lime content, which, combined with vertical strips, had the appearance of false ashlar (Fig. 5).

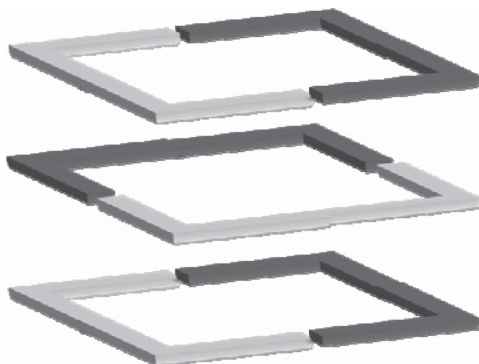
Figure 3. Building system used alternating the available U-shaped formwork (Vegas & Mileto).

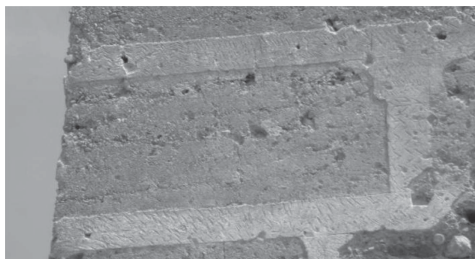
Figure 5. Strips of lime mortar sealing the joints at the top and the bottom of the tower (Vegas & Mileto).

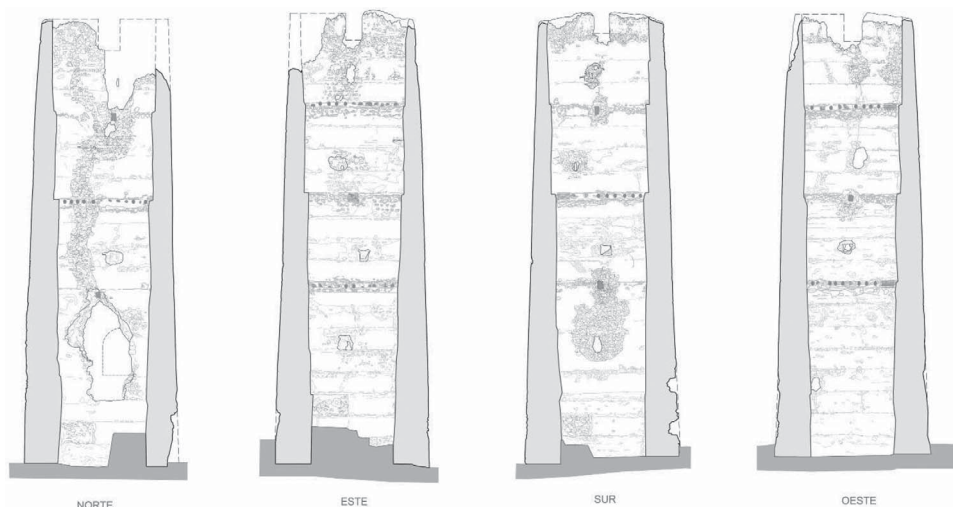
The three intermediate floors and the thin floor of the parapet walk (Fig. 6) were made with central girders and a large number of joists made of olive wood (Macchioni 2009), probably taken from the neighboring countryside and supplied by the local families.

Figure 6. Traces of the disappeared wooden floors in the interior of the tower (Vegas & Mileto).

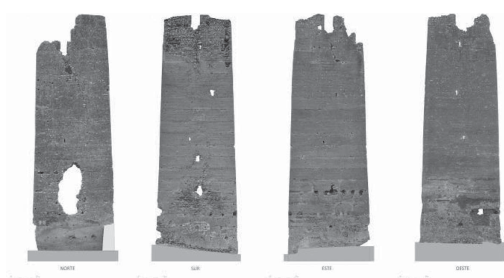
Before the restoration (Fig. 7), the state of conservation of its walls was relatively good, despite the loss of the roof and floors and the neglect to which the tower was condemned for some five centuries. The wooden floors had disappeared completely, probably due to a fire, of which traces could be seen. However, the intervention was urgently required mainly for two reasons: the pilgaging of the stone voussoirs of the double arch at the entrance that had caused the partial collapse of the interior surface over it and the hole at the entrance to the tower at the southwest corner, which had left it suspended in the air instead

Figure 7. State of the tower before the intervention (Vegas & Mileto).

of resting on the ground. On the other hand, the south façade of the tower had lost its surface and the stone filling of the wall could be seen at the top and bottom of the tower.

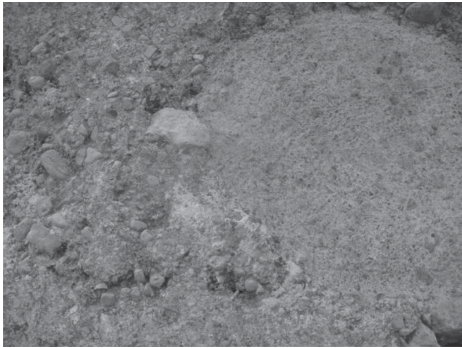
Figure 8. Integration of the gaps in the rammed earth wall (Vegas & Mileto).

parts of earth and gravel and one of lime (Kröner 2009) with a stone filling arranged in courses with the same structural features as the existing building, it was decided to improve the mixture by increasing the binder. The gaps at the southwest corner and the hole inside the north façade were filled with stone masonry bonded with mortar comprising 3 parts of earth and gravel and one of NHL-3 hydraulic lime (Fig. 8). As much local earth and gravel as possible were used, and were collected and sieved at the foot of the tower, so that the resulting mixture would not suffer from using gravel from a different place. In all the cases where it was deemed necessary, corrugated fiberglass rods were introduced to act as connectors. Perforations were drilled with the utmost care to avoid percussion, because despite the romantic appearance of the tower, several areas were found to be in danger of immediate collapse.

The stones that had fallen from the tower were used again, placed inside the wall and bonded in five successive layers that corresponded to the five historic building strata of each rammed earth module, not out of romanticism but in order to adjust the filling in of the gaps to the adjacent horizontal historic joints. Once one section of the surface was completed, it was rendered with the same mortar up to the next joint of the rammed earth module in the historic wall. The rendering lime-water in the surface was absorbed with a sponge and was brushed afterwards to show up the local gravel in the mixture. Then the next module of the rammed earth wall was treated in the same way, so as to mark the natural horizontal joints between modules, corresponding to the horizontal joints between the historic modules of the wall.

As determined in the preliminary tests, once the rendering had set, the added masses slightly tinted with natural soils were the same color as the paler shade of the binder in the historic wall, not darker. From this moment on, a restorer set about giving a patina to the added mass, by splashing on with a brush natural soils with a lime base in order to guarantee good integration.

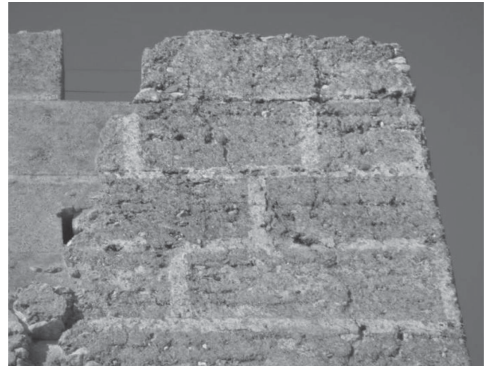
Figure 9. Tower crown with consolidation and reintegration treatments (Vegas & Mileto).

At the crown, in order to secure the surfaces in danger of immediate collapse in the north side and the merlons in the east and west sides that had lost stability due to erosion at the base, several possibilities were considered. Finally, it was decided to use the same procedure as to fill in the gaps because it ensured bonding and adherence, instead of more theoretical methods, which did not offer so much durability. The intention was not to restore the tower to its original shape, so these gaps were filled in up to the adjacent historic level and the degraded crest of the coping was respected in the areas where material did not need to be added to secure or stabilize the fabric (Fig. 9). Any attempt to outline the original shape of the upper edge was avoided at all costs, even where it was clearly the original coping, in an attempt to achieve the appearance of a hypothetical second-last course.

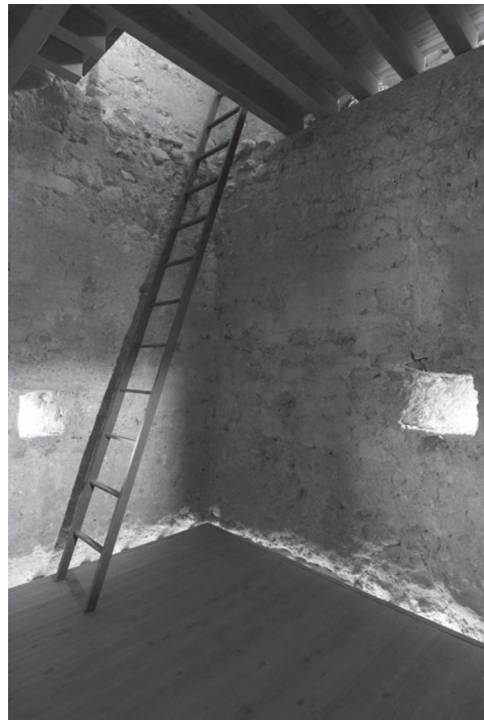
Figure 10. New floors and ladder in the interior of the tower (Baeza).

The roof and interior frameworks of the tower were built with pine girders and joists, according

to the rhythm marked by the traces on the historic walls, like the staircase (Fig. 10). It would have been logical to look for olive girders or joists or girders and joists from some wild tree like holm oak to imitate them if any of them were missing. In this case, as there were no remains, the framework was fashioned out of traditional materials like timber but with contemporary grammar.

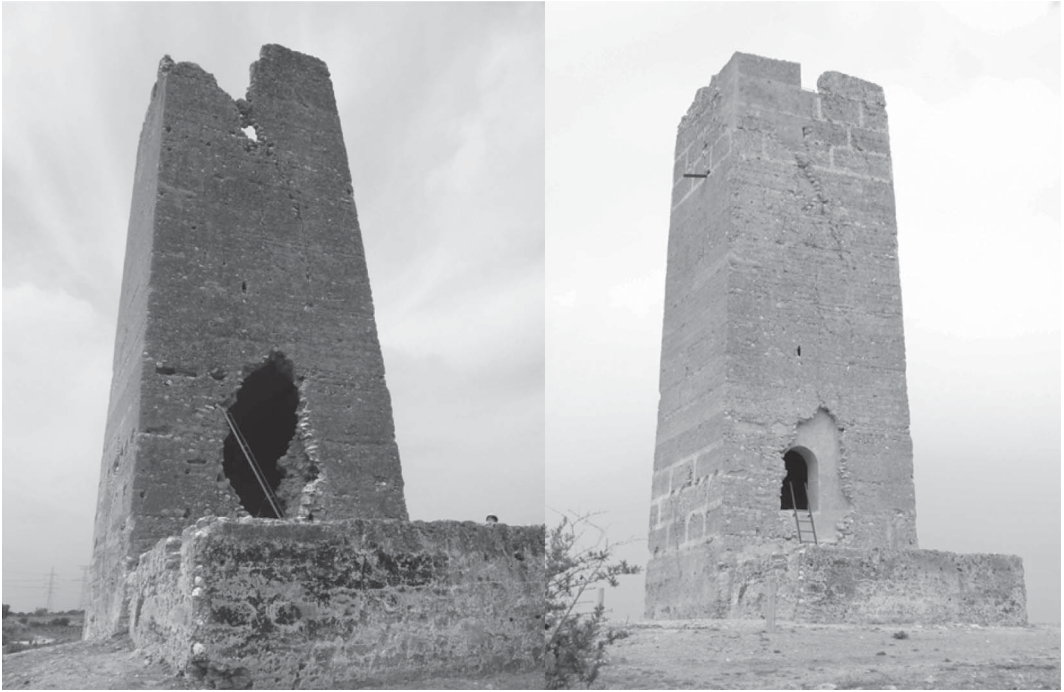
Figure 11. Bofilla Tower before and after the intervention (Vegas & Mileto/Baeza).

On the other hand, as described above, contextual integration was performed on the exterior, seeking to harmonize with the degree of degradation, patina and color of the preexisting adjacent areas to better guarantee the integration of the parts added to the building, which the authors have always given the central role in the intervention. When examined in detail, the additions have the appearance of *rigatino* in a historic painting, so that distinguishability had been guaranteed at the same time as the historic image and the value of the age of the building have been safeguarded.
